BAKER RANCH TREE ASSESSMENT REPORT

City of Lake Forest, California

MARCH 2011

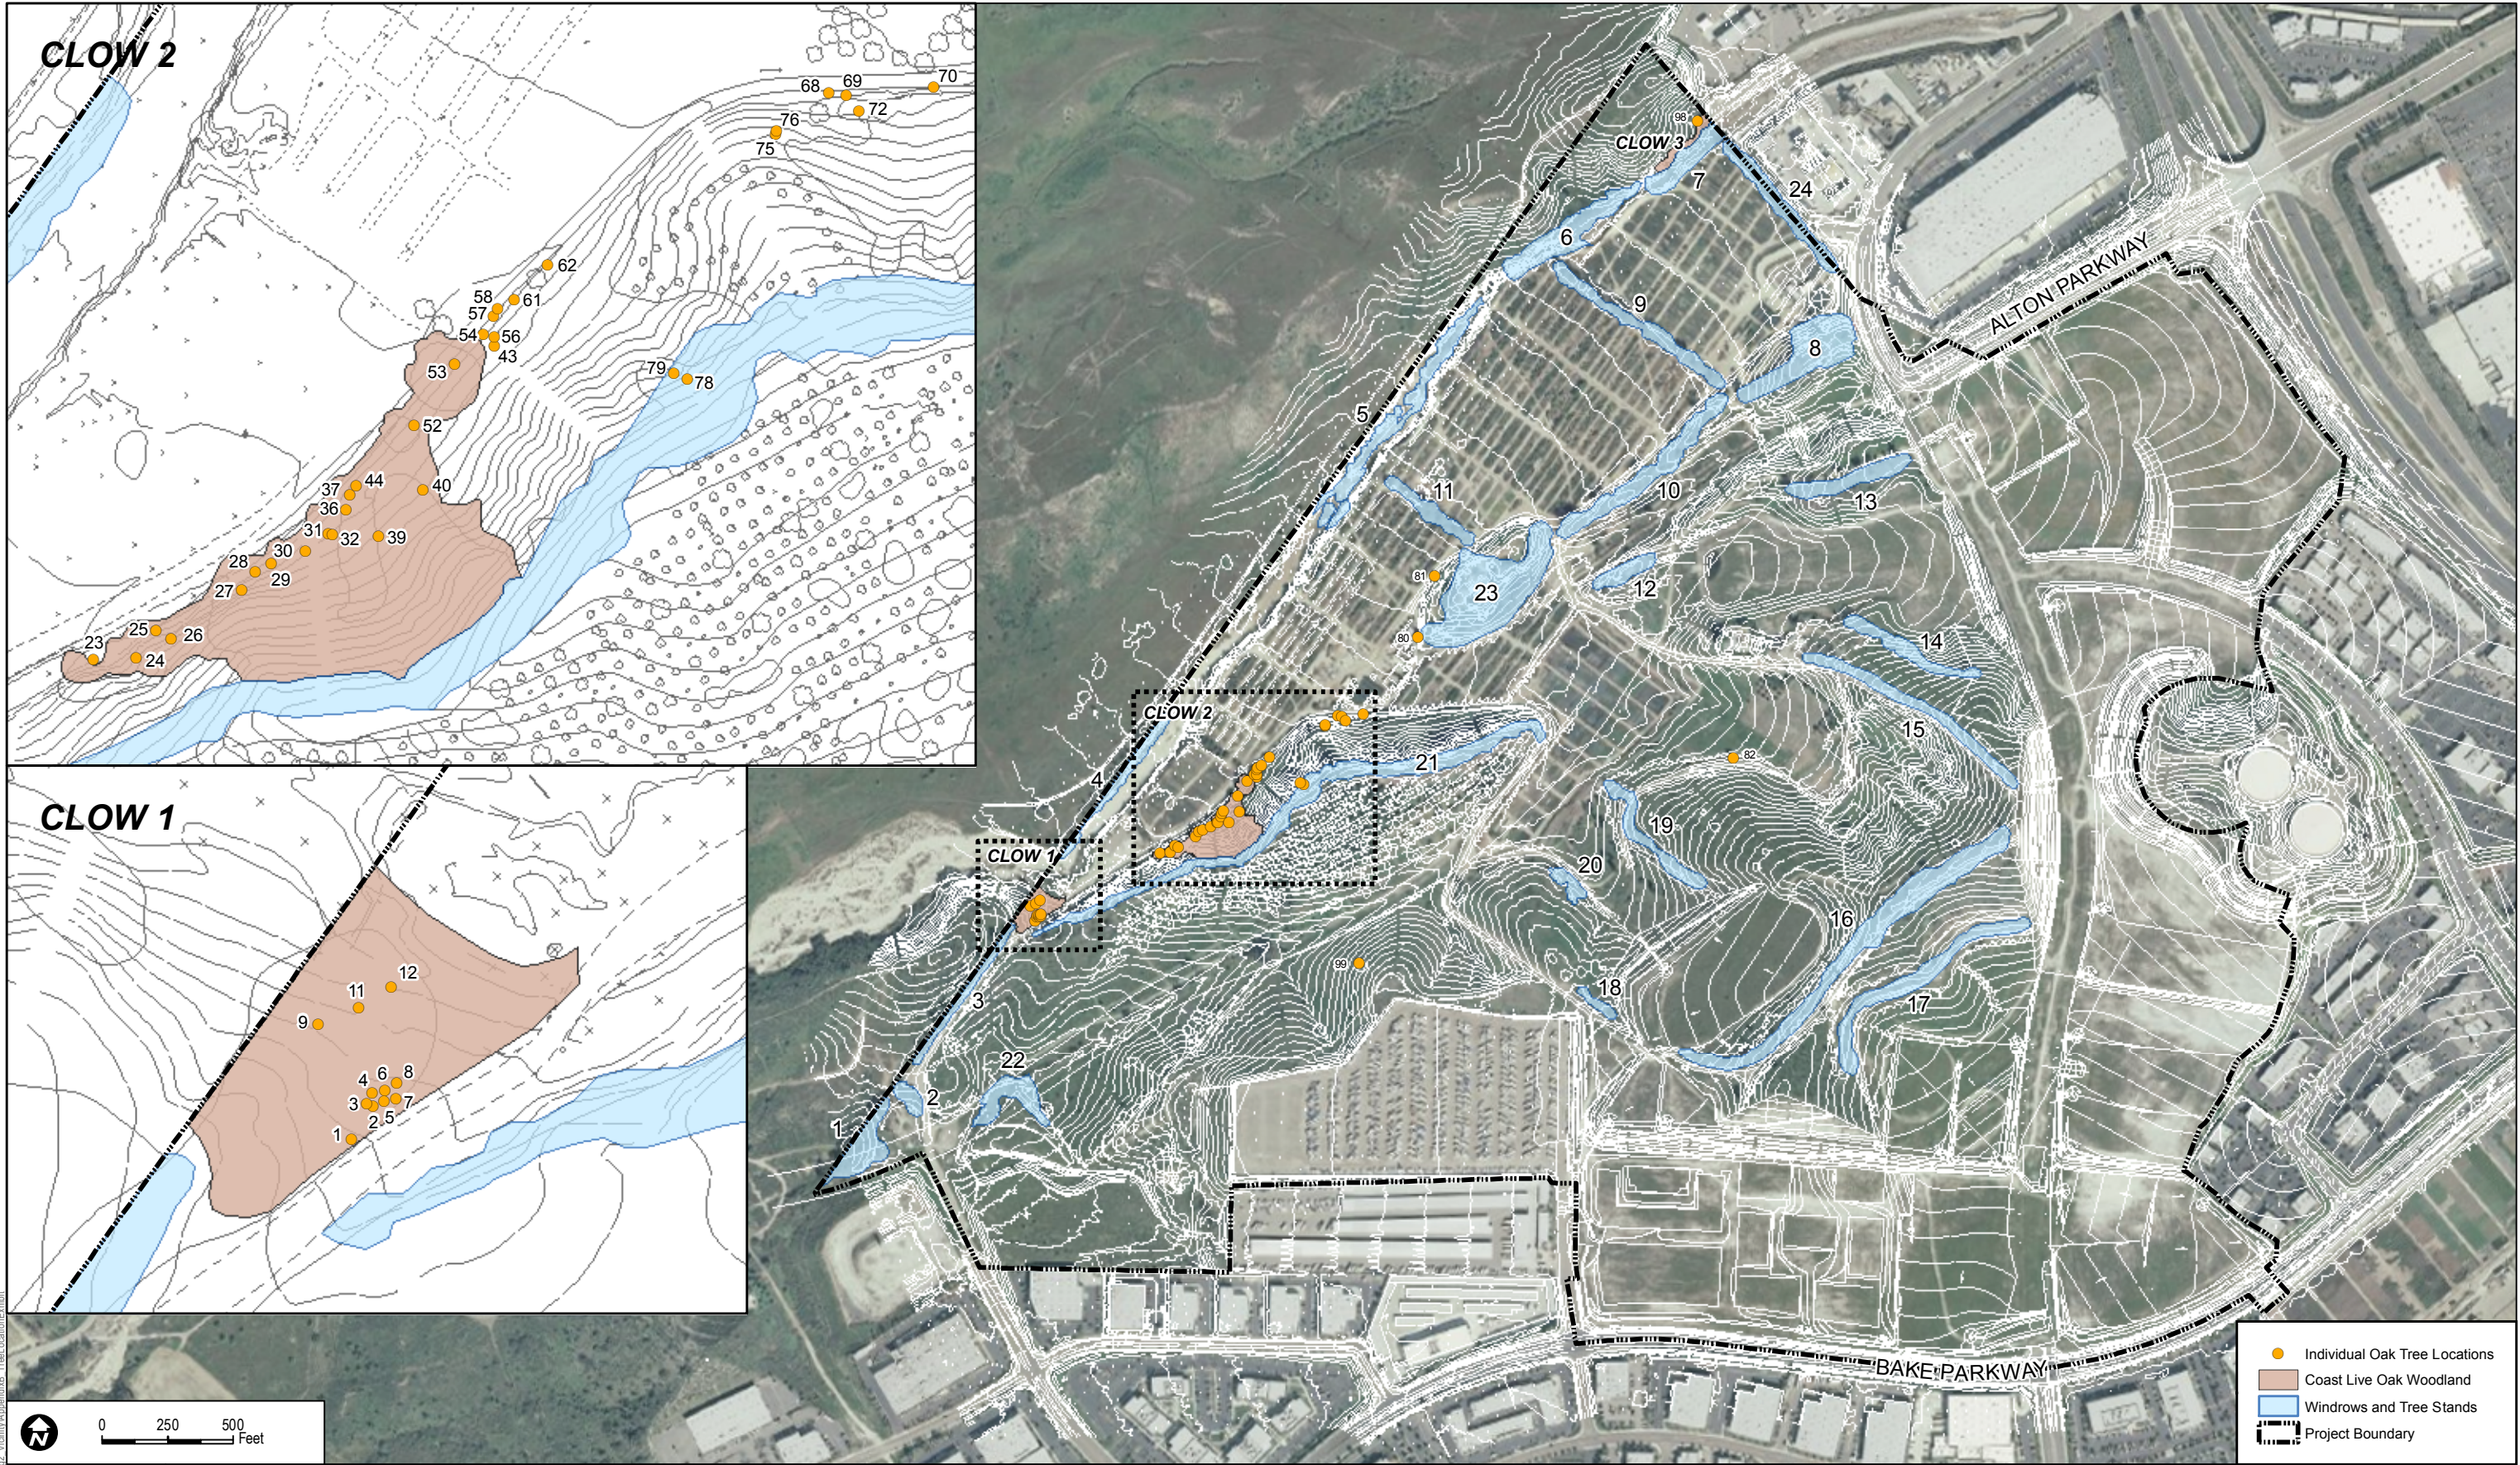
Table 3 summarizes the non-oak tree resources on the Baker Ranch site, by polygon. The Tree Location Exhibit in *Appendix B* presents locations for each tree stand/windrow, identified by polygon ID.
